TO: Emergency Services Advisory Committee (ESAC)
FROM: Ron Munds, General Manager
SUBJECT: **Agenda Item 7 – 05/21/2026 FAC Meeting**
Updated Station 15 Remodel/New Construction Cost Estimates

**LOS OSOS COMMUNITY SERVICES DISTRICT
FIRE STATION 15
CONDITIONS ASSESSMENT**

LOCS D FIRE STATION 15 DRAFT CONDITIONS ASSESSMENT

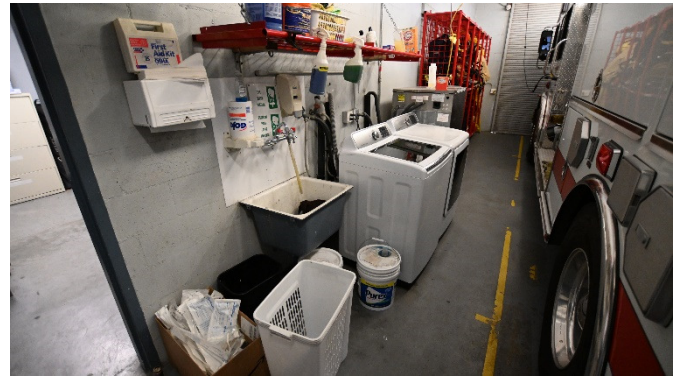
- Washers and dryers used for personnel uniforms and linens are located next to the Apparatus Bay, exposed to vehicle exhaust and other toxins.

Washer and Dryer in Apparatus Bay

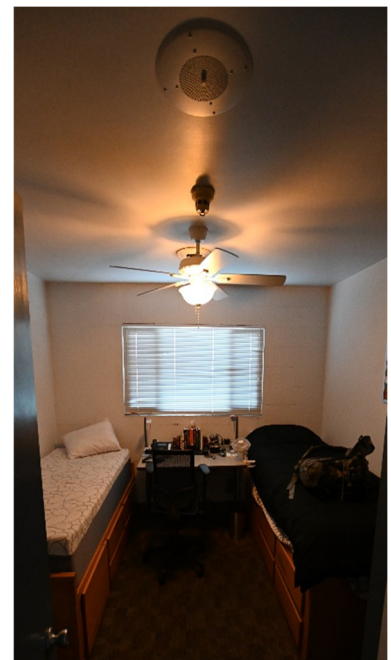
- The dorm rooms lack emergency egress windows. This is a code deficiency that is not required to be addressed, but can threaten Life/Safety should there be a fire in the Fire Station that prevents the occupants of the dorm rooms to exit.
- There are no person doors from the Apparatus Bay to the outside. The only way to exit is by opening the overhead doors or going through the administration area or living quarters. This is a code deficiency that threatens Life/Safety.

Dorm Room Windows are not Sized for Emergency Exiting

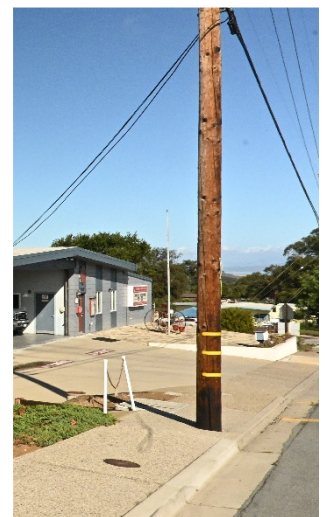
- Power Lines in Front of Apparatus Bay: The overhead lines that run across the front of the fire station are concerning. If the power poles or overhead power lines fall down, this will hinder the fire trucks’ ability to exit the station.

Power Lines Span two Power Poles in Front of the Apparatus Bay

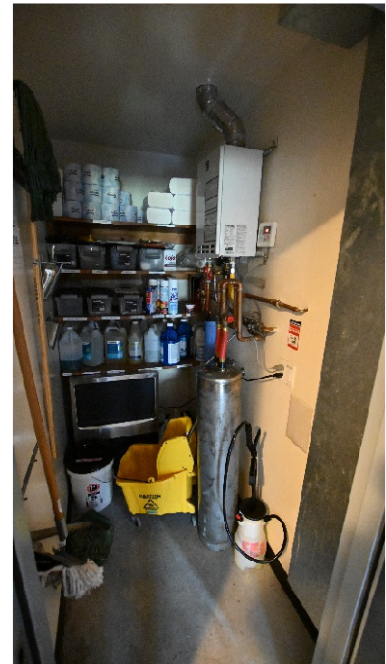
Under-sized Instant Wall-Mounted Water Heater

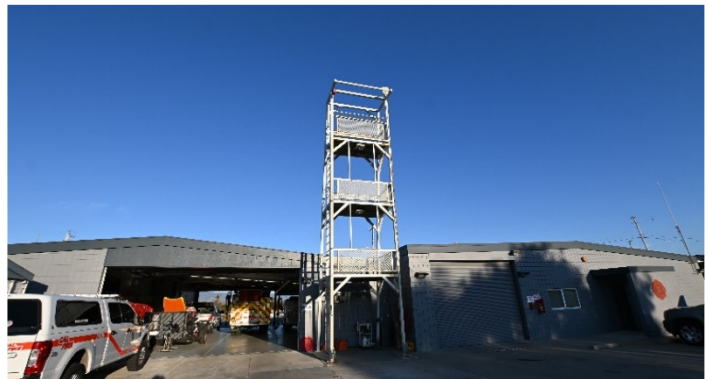
Existing Hose Drying Tower at the back of the Apparatus Bay

- Reconstruct transition at driveway approach and roadway intersection to reduce dip.
- Remove or relocate the existing hose tower for better vehicle maneuverability and to create access for a second folding door at the rear of the Apparatus Bay. Also, the hose drying tower is awkward to use. Replace the hose-drying tower with horizontal hose drying racks at a different location.
- Replace Generator to accommodate additional loads from new building.
